Loon Lake AIS Survey

October 19, 2021

Loon Lake

Aquatic Plant Survey 2021

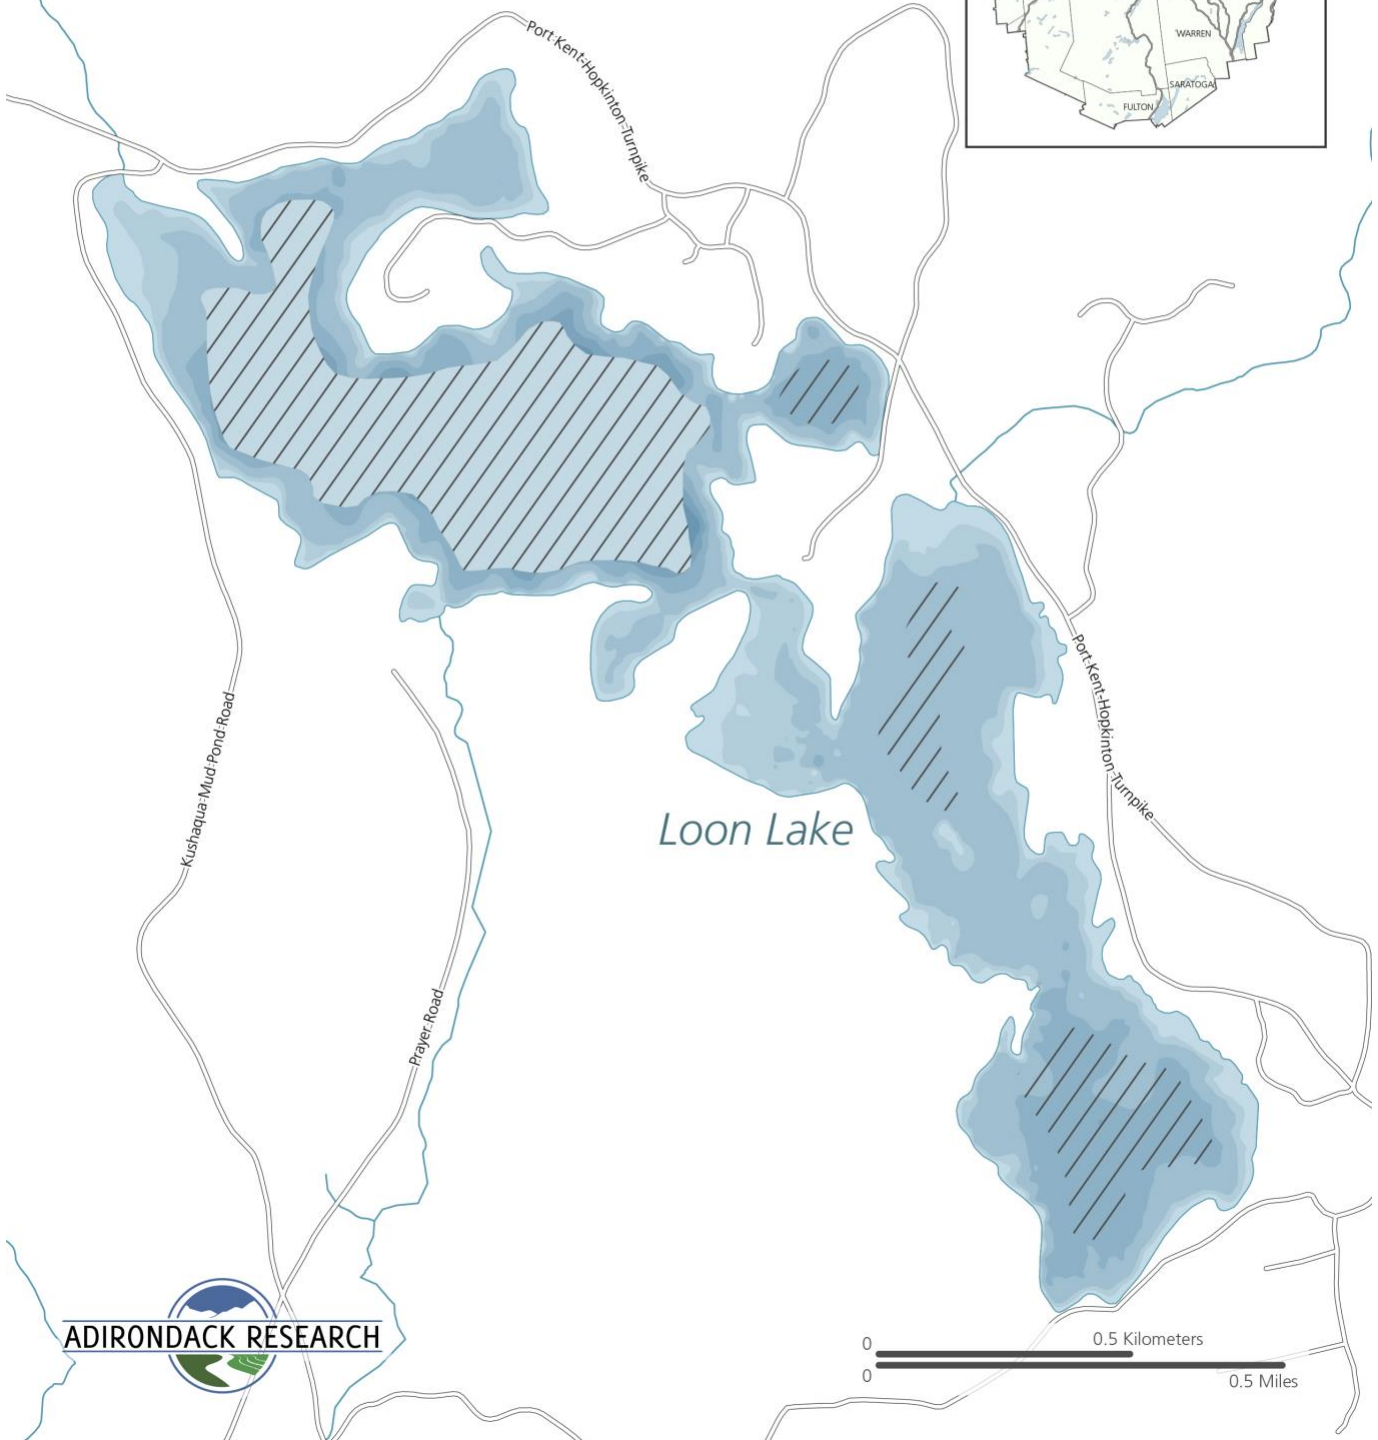
On the page following the 2021 map is a map created by Adirondack Research for Loon Lake Association in 2020. This map shows the Bathymetry collected in 2020 and informed our search patterns used in our 2021 survey.

Aquatic Plant Survey 2020

County: Franklin Date Surveyed: 8/26/2020
Town: Franklin AIS Bed Area (acres): 0
Lake Area (acres): 355 AIS Observed: None

Bathymetry (ft)
